HORSE BARN ASSESSMENT

POZ
Environmental

Contract # L10PA00209

Submitted to:
US, DOI, BLM

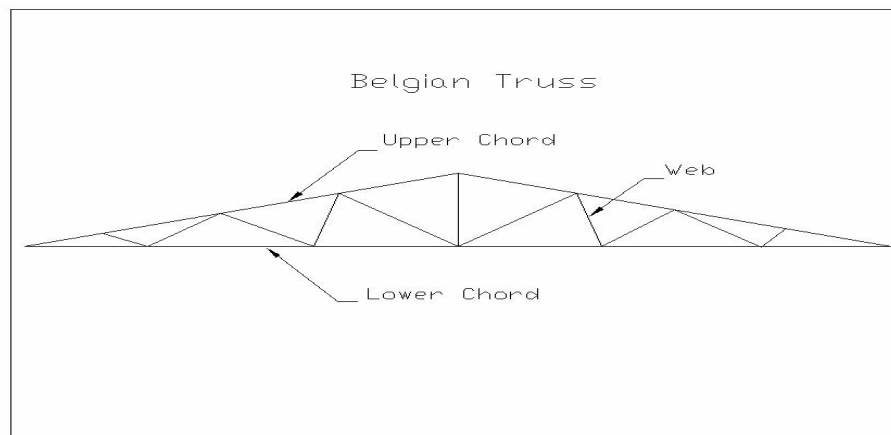
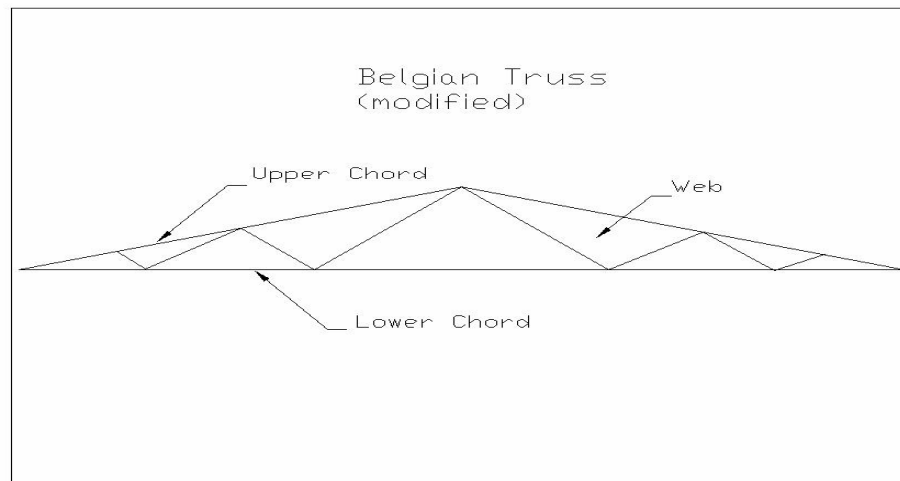
Roof Trusses – The roof trusses are constructed as a “modified” Belgian Truss; omission of a center web-member. The truss consists of either fir or pine and has three parts:

1. Upper Chord – consists of 2 by 10 by 16 feet long lumber (1.5 inches thick by 9.5 inches wide) butted at the apex and angling to a beam on each side to a distance of 31.05 feet. The rise of the Upper Chord is approximately 14.89° . The lumber is not a continuous length of board, but rather spliced together with metal meshed fasteners. These fasteners are present on both sides of the joint or only one side.

2. Lower Chord – consist of 2 by 10 by 16 feet long lumber (1.5 inches thick by 9.5 inches wide) intersecting the Upper Chord on a beam and spanning a distance of 60 feet. The lumber is not a continuous length of board, but rather spliced together with metal meshed fasteners. These fasteners are present on both sides of the joint or only one side.

3. Web – members consist of 4 - 2 by 4 lumber (1.5 inches thick by 3.5 inches wide) with varying lengths connecting the Upper Chord with the Lower Chord on each side of the truss spanning a distance of 60 feet. The average distance of individual panel points (intersecting the Upper Chord) is 8.5 feet. There is no vertical web member in the center of the truss to fully describe this truss as a Belgian.

Roof Trusses –The weight of each truss is 346.7 pounds (pine) or 476.5 pounds (fir). An eight-foot distance between doubled-up trusses seems to be suspect in a construction short-cut. It would be more stable and rational to space the trusses on 4-foot centers, which would decrease weight (approximately 5500 pounds) and forces on each intermediate panel. The rotted northeast truss is an obvious problem that needs to be addressed in the very near future. Although the trusses are still in position and carrying the roof loads, suspected movement has taken place over time. This movement has been identified in the titling of one truss at the south end of the barn in the arena area. It was also noted that the Lower Chord span is exceptionally long (60 feet). Some trusses, also in the southern end of the arena area, are bowing horizontally in the lower chord member. Since no supports are located between each truss, it can be hypothesized that horizontal bending is taken place. This is probably do to the suspected movement of the trusses at its apex. It is proposed that sprinkler systems are to be installed, which will add more weight to the Lower Chord and increase the weight on the moment. The lower chord members are butted together and fastened with metal plates and grommets at 16-foot intervals for the 60-foot span. No web members are arranged vertically, and only consist of 2 by 4 lumber intersecting the Upper with the Lower Chord members (2 by 10 lumber). Although the web members are attached to the Upper and Lower Chord members, the configuration and dimensions of the metal plating is inconsistent in size and application. It is obvious that there are no safety factors built into the application and construction of these roof trusses.

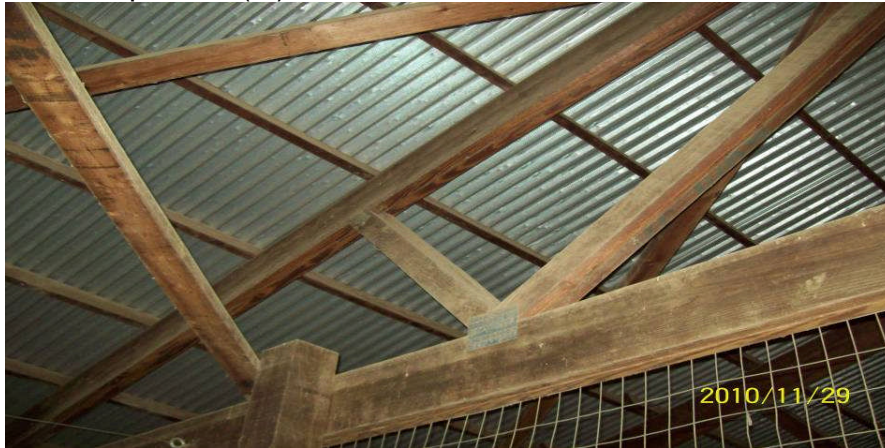
The roof trusses are paired, placed on 8-foot centers, and jointed with 16 common nails. The nailing is either staggered or paired. Temporary supports that were used in the construction phase are still present. These supports are either not operational or bowed from suspected movement of trusses. The trusses sit on a wooden beam at each end of the 60-foot span. Tipping to the south / back of barn was observed for trusses in the south or middle area of the arena. The most northeast corner truss is rotted. The weight of each truss is 346.7 pounds (pine) or 476.5 pounds (fir).

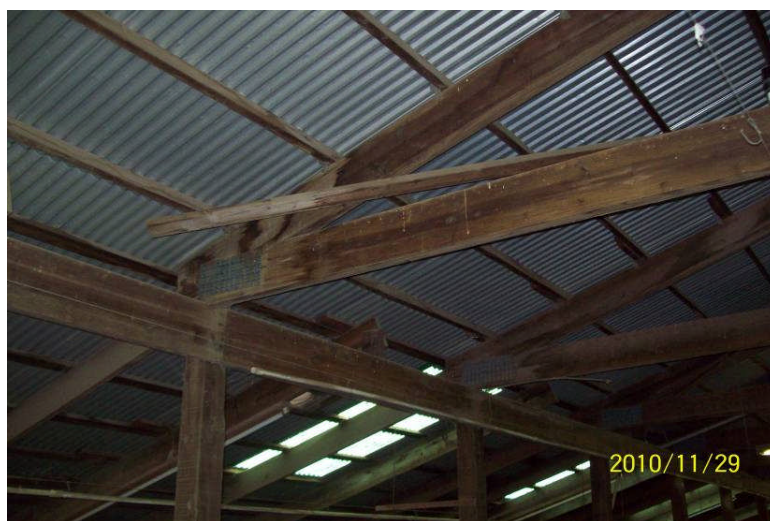
Columns – The columns consists of 6" by 6" pine posts that are placed in post holes and extends upward to meet the elevation of the trusses. The soil around three posts (one arena and two exterior posts) were excavated to a depth of 12 to 18 inches. The excavation showed that each of the buried portion of the beam had a tar-like coating on the surface of the wood. Soil around the arena post consisted of a sandy-silt with minor clay component with easy excavation and apparent voids. One exterior column showed rotting at the surface of the wood in the soil. The arena columns were placed on 8-foot centers along the perimeter of the Arena, and 10-foot centers along the exterior perimeter of the barn with the exception of the large doorways, which is 20 feet.

Beams – The beams consisted of 2 by 12 lumber 8 feet in length which were nailed to each face of the column with 16 common nails in sets of three vertically. The beam had two components: an inner beam with the facing position toward the arena, and an outer beam positioned toward the horse stalls. The beams were not equal in elevation but had a 2.5-inch offset. The trusses were positioned on the top of the inner beam (higher in elevation), and the rafters on the outside beam (lower in elevation). At one inspection point, the inside beam was compressed by 3/8 of an inch under the position of the truss. The truss was not placed on the top of the column but rather on the inside beam at a point where it off-set the column (see photo above).

Columns – The columns are placed in soil with a thin coating of preservative. It would have been more fitting and structurally sound to place each column on top of concrete. Each column consists of 6" by 6" pine posts that are placed in post holes and extends upward to

meet the elevation of the trusses. The soil around three posts (one arena and two exterior posts) were excavated to a depth of 12 to 18 inches. The sampling showed that each of the buried portion of the beam had a tar-like coating on the surface of the wood. Soil around the arena post consisted of a sandy-silt with minor clay component with easy excavation and apparent voids. One exterior column showed rotting at the surface of the wood in the soil. The arena columns were placed on 8-foot centers along the perimeter of the Arena, and 10-foot centers along the exterior perimeter of the barn with the exception of the large doorways, which is 20 feet. Since the posts are the limiting factor for the structural integrity of the barn, more sampling below the ground surface is needed.

Beams – The beams consisted of 2 by 12 lumber 8 feet in length which were nailed to the face of the column with 16 common nails in three vertically sets. The beam had two components: an inner beam with the facing position toward the arena, and an outer beam positioned toward the horse stalls. The beams were not nailed together and not equal in elevation but had a 2.5-inch offset. The trusses were positioned on the top of the inner beam (higher in elevation), and the rafters between the inner column and the exterior wall of the barn on the outside beam (lower in elevation). At one inspection point, the inside beam has a compression of 3/8 of an inch under the position of the truss. The truss was not placed on the top of the column but rather on the inside beam at a point where it off-set the column. The beams have held the weight of the trusses and roof components, which was calculated to be 5500 pounds at each truss intersection. However, the weight of the roof relies on the shearing strength of the nail set and the absence of horizontal movement of the beam from the column; for example, this structure would not be appropriate for active tectonic zones. Although wind and snow forces were calculated in the 5500 pound load, periodic inspection of this loading point should be maintained because no safety factors were considered in the construction of this structure.

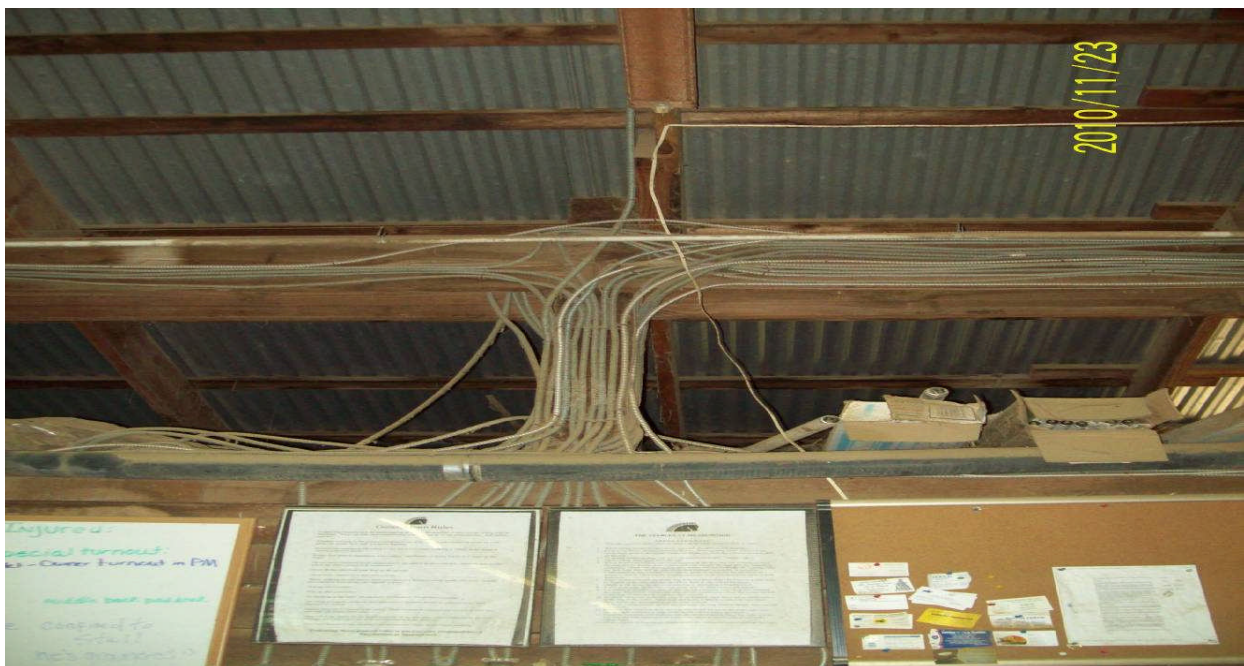
Wiring – The wiring consists of 10-2 BX and 12-2 BX wire. The wiring is visible and stapled to the beams and posts of the barn and run to supply power to the stalls, lighting fixtures, dust suppression systems, and power connections in general. The wiring is metal shielded to protect the wire from rodents and horses from chewing through the protective coating. The wire jacket that are exposed to the mist of the dust suppression system has a rusted surface. This is prevalent at the overhead light fixtures in the aisle between the arena and stalls.

Wiring – The wiring consists of 10-2 BX and 12-2 BX wire. The wiring is visible and stapled to the beams and posts of the barn and run to supply power to the stalls, lighting fixtures, dust suppression systems, and power connections in general. The wiring is metal shielded to protect the wire from rodents and horses from chewing through the protective coating. The wire jacket that are exposed to the mist of the dust suppression system has a rusted surface. This is prevalent at the overhead light fixtures in the aisle between the arena and

stalls. Evidence of rust on the metal jacket of the wire cable suggest that it is exposed to moisture and probably from the dust suppression system. This condition presents a risk for electric shock or worse to the public and livestock. The design for the installation of the dust suppression system was either non-existent, not followed, or ill conceived.

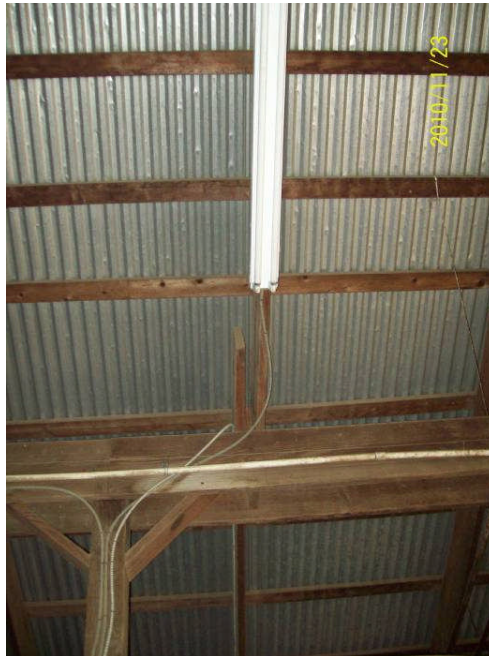
Lighting – The lighting consists of elongated florescent tubes throughout the barn. The light fixtures are situated near and at a lower or equal elevation than the dust suppression system. Switches of the lighting are located on the walls with horse protective shields.

Lighting – The lighting consists of elongated florescent tubes throughout the barn. The light fixtures are situated near and at a lower or equal elevation than the dust suppression system. Switches of the lighting are located on the walls with horse protective shields. The elevation of the lighting with respect to the dust suppression system should have been at a significantly higher elevation than both the lighting and switches.

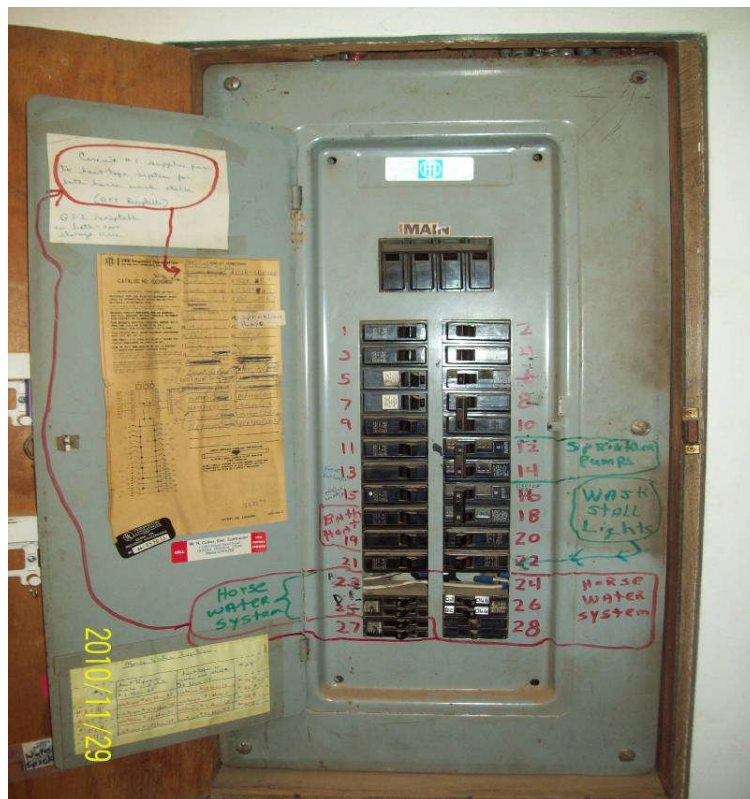
Distribution Box – The panel box is labeled ITT Imperial Corporation. The total amperage coming into the box is 200 amps. There are 28 positions and 26 breakers, labeled as follows:

There were no loose wires that were not capped, and no wires jumping or crossing breakers.

Distribution Box – The panel box is labeled ITT Imperial Corporation. The total amperage coming into the box is 200 amps. There are 28 positions and 26 breakers without any ground fault breakers in the box. From the observations that were made, it appears that there were no breakers that were overloaded. The labeling of this box was confusing. However, the lighting and receptacles are equal to or less in elevation to the dust suppression system. If ground fault breakers were installed, it would probably make these receptacles and lighting inoperable. Again, it is obvious that the facilities of this structure was planned without any safety considerations.

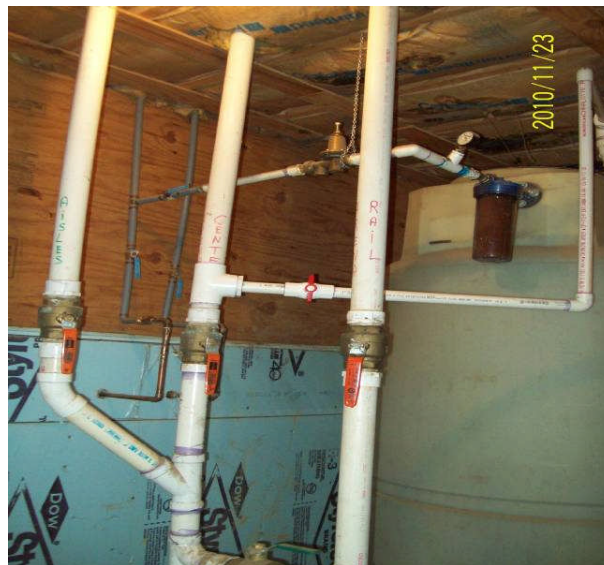
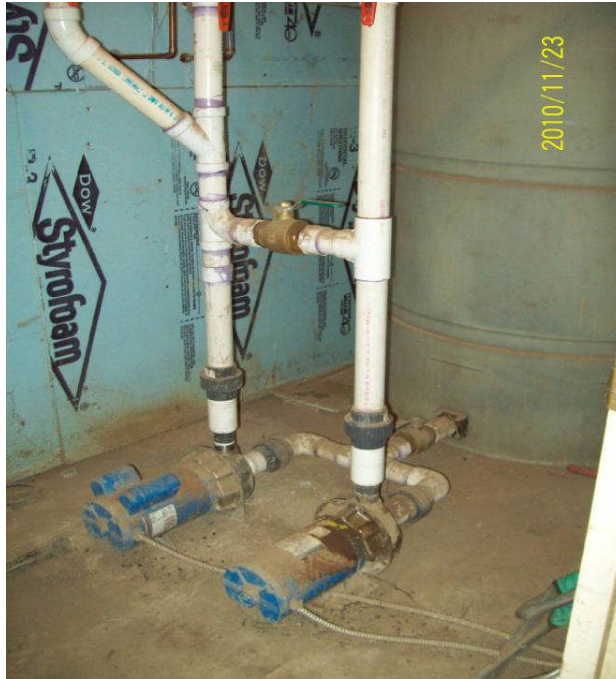
Dust Suppression System – The dust suppression system consisted of two Franklin Electric pumps, piping running the length of the barn in eight runs with sprayer nozzles on the top of the pipe spaced continuously throughout the run. The runs were also spaced as follows: 4 lines run longitudinally through the arena area and 2 lines ran longitudinally through the aisles between the stalls and the arena. The pumps, shown in the photo below, has the following nomenclature (Table #2 below).

Dust Suppression System – The dust suppression system consisted of two Franklin Electric pumps, piping running the length of the barn with sprayer nozzles on the top of the pipe spaced continuously throughout the run. The runs were also spaced as follows: 4 lines run longitudinally through the arena area and 2 lines ran longitudinally through the aisles between the stalls and the arena. These lines should have been positioned lower, especially with respect to the electrical system. A dust suppression system is a necessary safety consideration because electrical arching or an open flame in a dusty area can cause dust explosions. However, location of the system relative to electrical wiring is also important.
